CSD/NPIC 43/65

HIGHWAY BRIDGE, ROUTE 9
TCHEPONE AREA, LAOS
1642N 10613E

HIGHWAY BRIDGE, ROUTE 9 TCHEPONE AREA, LAOS 16-42N 106-13E

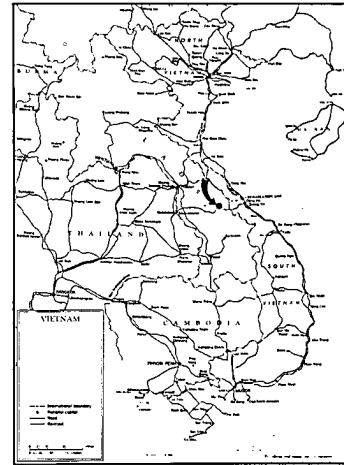
NPIC J-7406 (2/65)

DAMAGE TO THE EASTERNMOST SPAN OF THE FOUR-SPAN, HALF-THROUGH,
STEEL-TRUSS ROUTE 9 HIGHWAY BRIDGE OVER THE SE BANG HIENG (RIVER)
1.4 NM NORTHWEST OF TCHEPONE, RENDERING IT IMPASSABLE TO VEHICLES.

BE PARTIALLY COLLAPSED. FLOODING ACTION WAS APPARENT ON BOTH
BANKS OF THE RIVER, AND THERE WAS NO INDICATION OF ATTEMPTS TO
FORD THE RIVER.

ROAD BY-PASS APPROXIMATELY 0.2 NM EAST OF THE BRIDGE, WHICH
CONNECTED ROUTE 9 WITH THE PARTIALLY-COLLAPSED SPAN. THE BRIDGE
APPEARED TO BE SERVICEABLE FOR VEHICULAR TRAFFIC.

REVEALED A NEWLY-IDENTIFIED STAIRWAY CONNECTING THE COLLAPSED
SPAN WITH ROUTE 9. NO BOMB DAMAGE WAS OBSERVED.

[] REVEALS THE SPAN JUST WEST OF THE PREVIOUSLY DAMAGED SPAN TO HAVE COLLAPSED INTO THE SE BANG HIENG (RIVER) AS A RESULT OF BOMB DAMAGE, RENDERING THE BRIDGE UNSERVICEABLE. THE STAIRWAY HAS BEEN DESTROYED ALSO. SIX BOMB CRATERS (THREE SHOWN ON GRAPHIC) ARE OBSERVED IN THE AREA: ONE AT EACH END OF THE NEWLY-COLLAPSED SPAN, ONE AT THE EASTERN END OF PREVIOUSLY-DAMAGED SPAN, ONE JUST SOUTH OF THE EASTERNMOST PIER, AND TWO ON ROUTE 9 JUST EAST OF THE BRIDGE.
